# Home Report

# Single Survey

<b>Property address</b>	Fairlie View House 1 Dudhope Terrace Dundee DD3 6HG
<b>Customer</b>	Catriona MacPhee
<b>Customer address</b>	Fairlie View House 1 Dudhope Terrace Dundee DD3 6HG
<b>Prepared by</b>	Select Surveyors Ltd
<b>Date of Inspection</b>	20 <sup>th</sup> February 2026

## 1. Information and scope of inspection

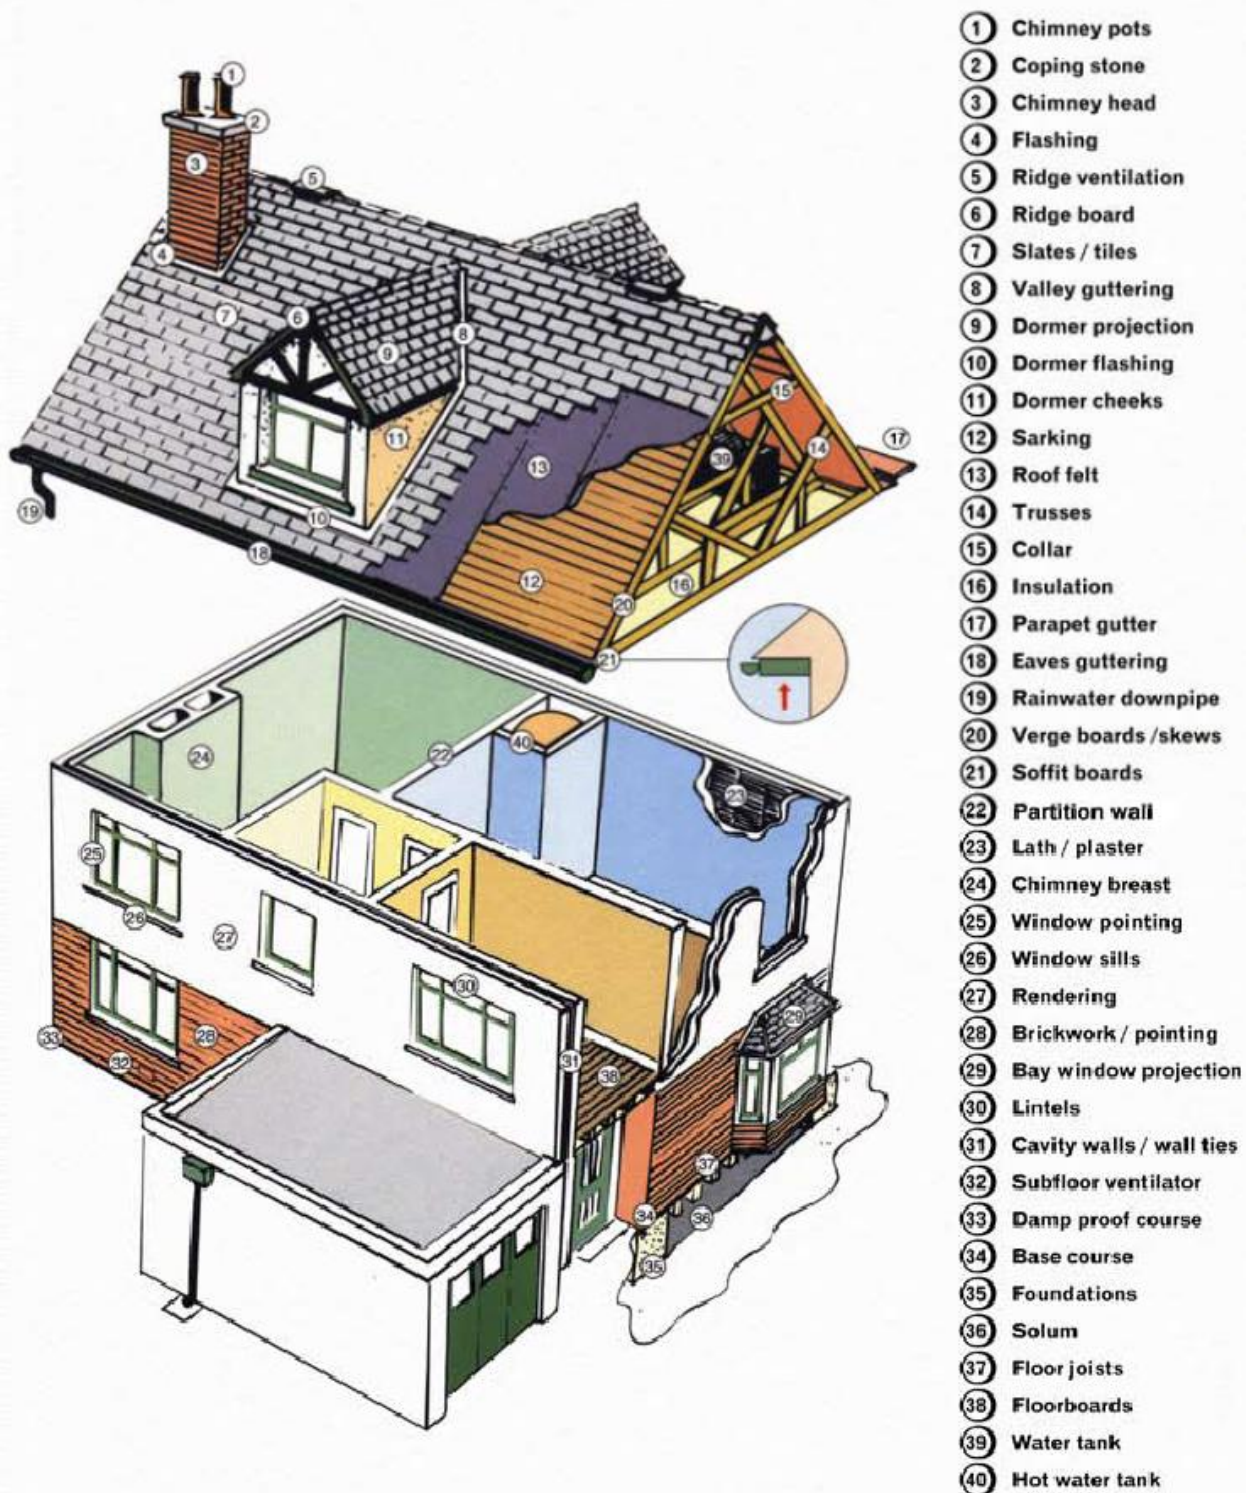
## Sectional Diagram showing elements of a typical house

Reference may be made in this report to some or all of the above component parts of the property. This diagram may assist you in locating and understanding these items.

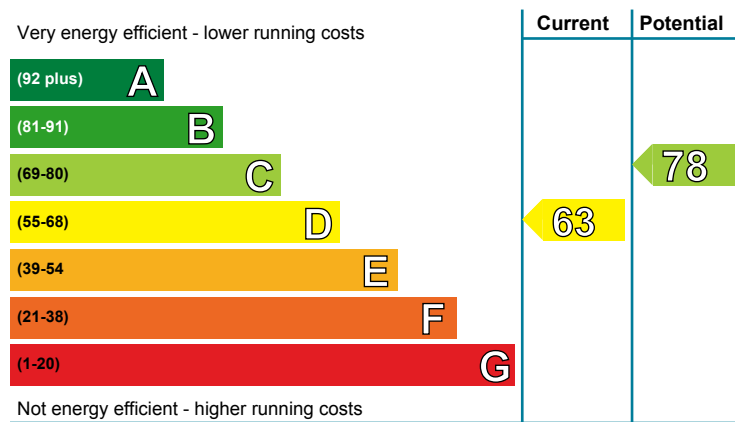
## Energy Efficiency Rating

This graph shows the current efficiency of your home, taking into account both energy efficiency and fuel costs. The higher this rating, the lower your fuel bills are likely to be.

Your current rating is **band D (63)**. The average rating for EPCs in Scotland is **band D (61)**.

The potential rating shows the effect of undertaking all of the improvement measures listed within your recommendations report.

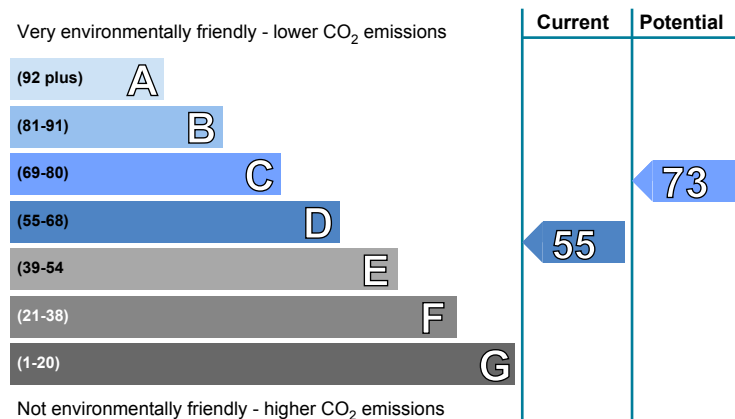
## Environmental Impact (CO<sub>2</sub>) Rating

This graph shows the effect of your home on the environment in terms of carbon dioxide (CO<sub>2</sub>) emissions. The higher the rating, the less impact it has on the environment.
