Home Report

11 West Park Road
Dundee DD2 1NU

Single Survey

Property Address	11 West Park Road Dundee DD2 1NU
Customer	Mrs A L Den Hertog
Prepared by	Graham + Sibbald LLP
Date of Inspection	20/08/2025

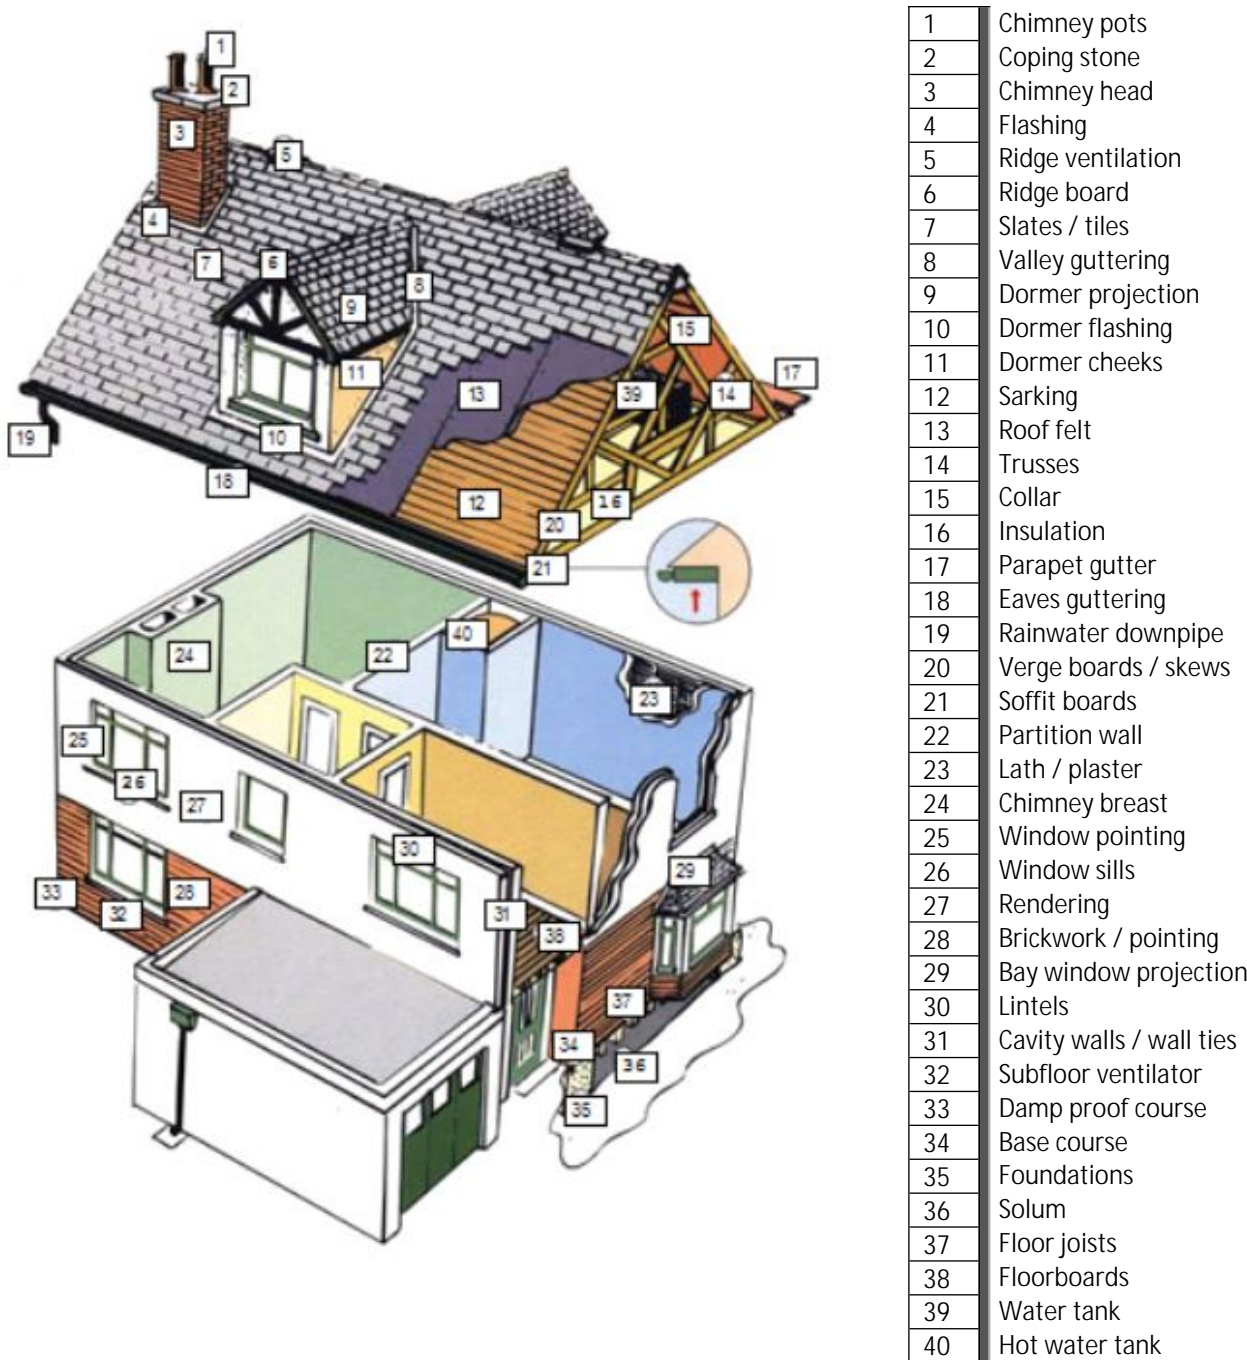
Sectional diagram showing elements of a typical house

Reference may be made in this report to some or all of the above component parts of the property. This diagram may assist you in locating and understanding these items.
