YOUR ONESURVEY
HOME REPORT

The Toll House
Baldovie Toll
Dundee
DD5 3NW

SINGLE SURVEY

A report on the condition of the property, with categories being rated from 1 to 3.

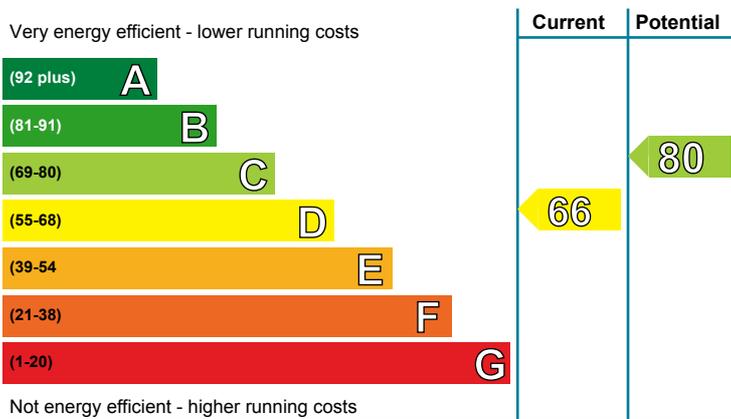
Energy Efficiency Rating

This graph shows the current efficiency of your home, taking into account both energy efficiency and fuel costs. The higher this rating, the lower your fuel bills are likely to be.

Your current rating is **band D (66)**. The average rating for EPCs in Scotland is **band D (61)**.

The potential rating shows the effect of undertaking all of the improvement measures listed within your recommendations report.

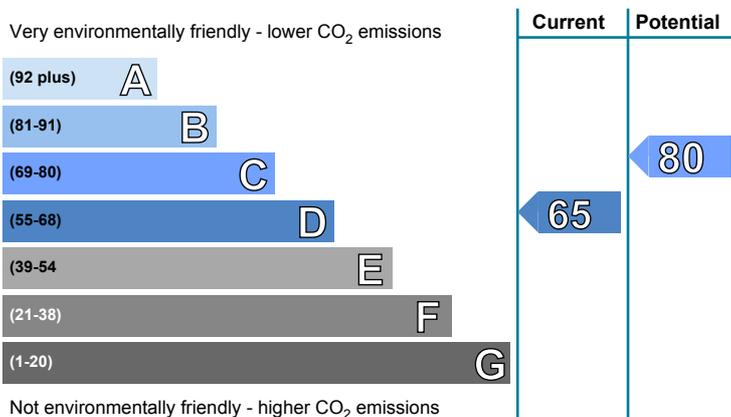
Environmental Impact (CO₂) Rating

This graph shows the effect of your home on the environment in terms of carbon dioxide (CO₂) emissions. The higher the rating, the less impact it has on the environment.
