YOUR ONESURVEY
HOME REPORT

12 Sutherland Crescent
Dundee
DD2 2HP

SINGLE SURVEY

Surveyor Reference	EA5984
Customer	Mr. Samuel Thomson
Selling address	12 Sutherland Crescent Dundee DD2 2HP
Date of Inspection	10/06/2026
Prepared by	Graeme Millar, MRICS Dundee - Allied Surveyors Scotland Ltd

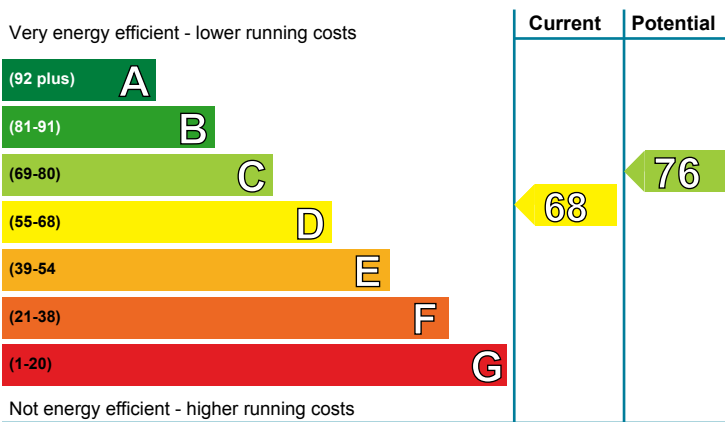
Energy Efficiency Rating

This graph shows the current efficiency of your home, taking into account both energy efficiency and fuel costs. The higher this rating, the lower your fuel bills are likely to be.

Your current rating is **band D (68)**. The average rating for EPCs in Scotland is **band D (61)**.

The potential rating shows the effect of undertaking all of the improvement measures listed within your recommendations report.

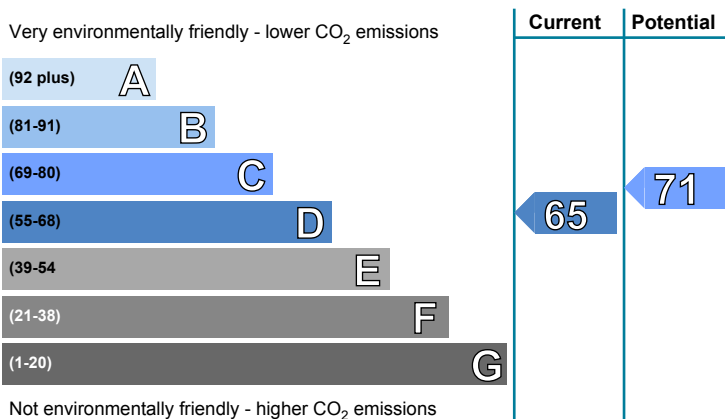
Environmental Impact (CO₂) Rating

This graph shows the effect of your home on the environment in terms of carbon dioxide (CO₂) emissions. The higher the rating, the less impact it has on the environment.
