Home Report

Single Survey

Property address	Fairylea House Alyth Blairgowrie PH11 8NU
Customer	Rex Oratokhai and Paul Kalu
Customer address	
Prepared by	Shepherd Chartered Surveyors
Date of inspection	03/06/2025

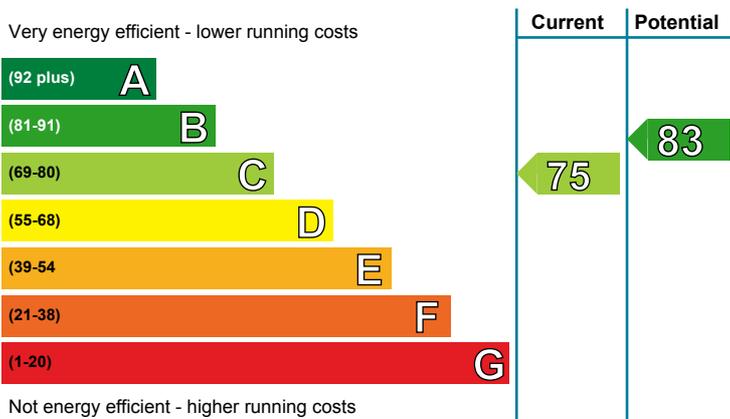
Energy Efficiency Rating

This graph shows the current efficiency of your home, taking into account both energy efficiency and fuel costs. The higher this rating, the lower your fuel bills are likely to be.

Your current rating is **band C (75)**. The average rating for EPCs in Scotland is **band D (61)**.

The potential rating shows the effect of undertaking all of the improvement measures listed within your recommendations report.

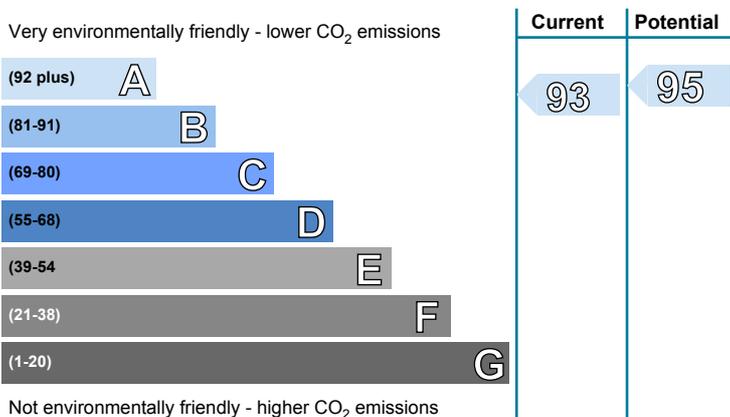
Environmental Impact (CO₂) Rating

This graph shows the effect of your home on the environment in terms of carbon dioxide (CO₂) emissions. The higher the rating, the less impact it has on the environment.

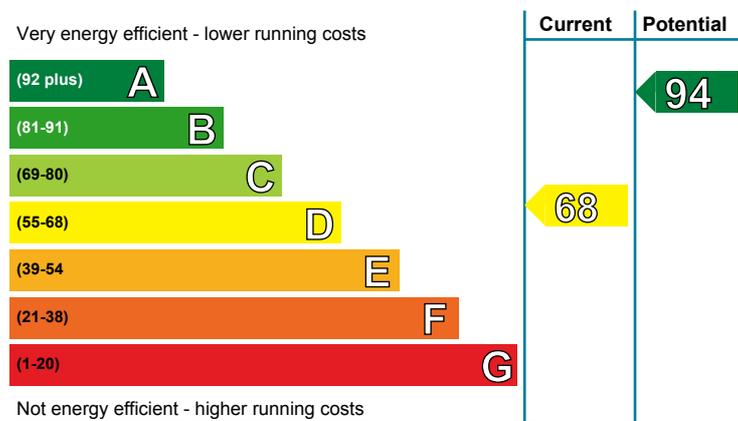
Energy Efficiency Rating

This graph shows the current efficiency of your home, taking into account both energy efficiency and fuel costs. The higher this rating, the lower your fuel bills are likely to be.

Your current rating is **band D (68)**. The average rating for EPCs in Scotland is **band D (61)**.

The potential rating shows the effect of undertaking all of the improvement measures listed within your recommendations report.

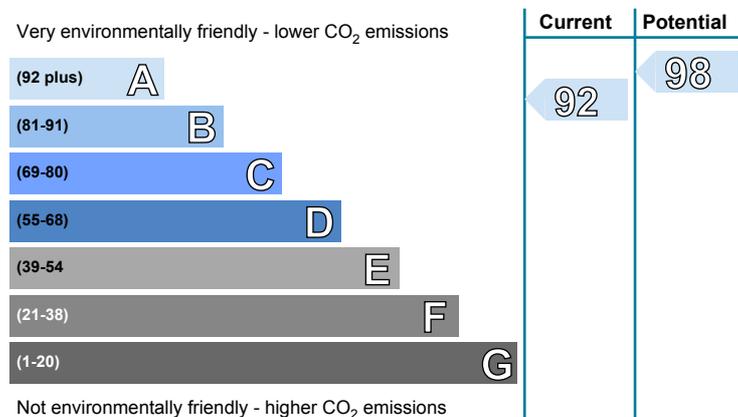
Environmental Impact (CO₂) Rating

This graph shows the effect of your home on the environment in terms of carbon dioxide (CO₂) emissions. The higher the rating, the less impact it has on the environment.
