YOUR ONESURVEY  
**HOME REPORT**

2 Craigton Cottage  
Craigton  
Kirriemuir  
DD8 5NR

# SINGLE SURVEY

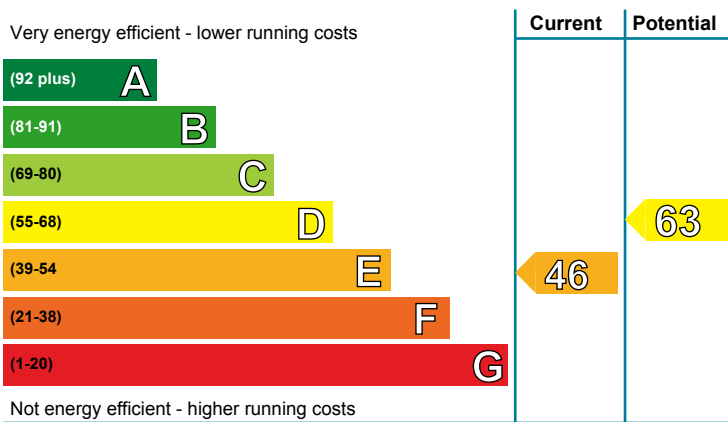
## Energy Efficiency Rating

This graph shows the current efficiency of your home, taking into account both energy efficiency and fuel costs. The higher this rating, the lower your fuel bills are likely to be.

Your current rating is **band E (46)**. The average rating for EPCs in Scotland is **band D (61)**.

The potential rating shows the effect of undertaking all of the improvement measures listed within your recommendations report.

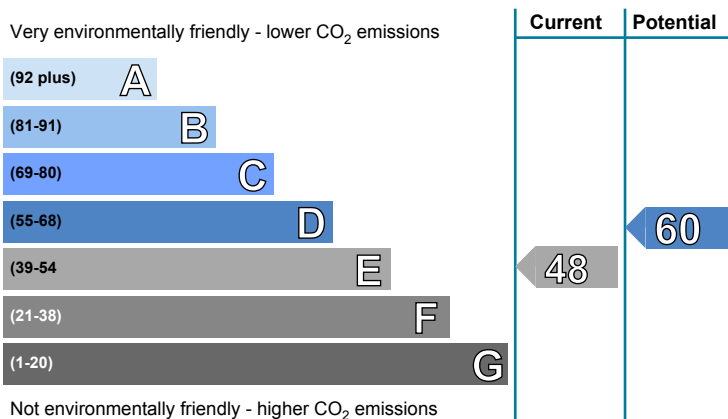
## Environmental Impact (CO<sub>2</sub>) Rating

This graph shows the effect of your home on the environment in terms of carbon dioxide (CO<sub>2</sub>) emissions. The higher the rating, the less impact it has on the environment.
