YOUR ONESURVEY
HOME REPORT

Flat 1/L
59 Dock Street
Dundee
DD1 3DU

SINGLE SURVEY

Single Survey

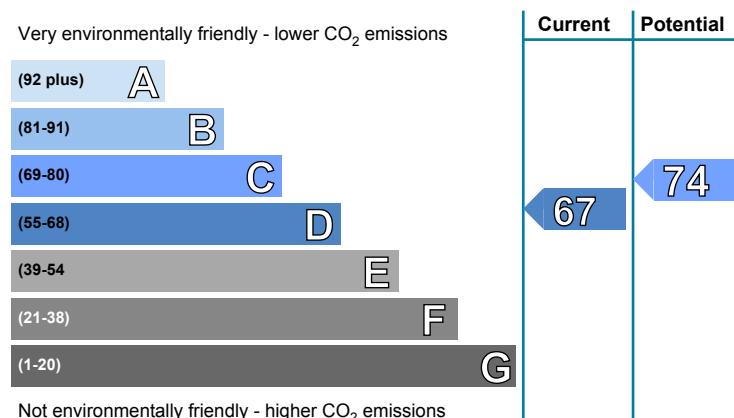
Environmental Impact (CO₂) Rating

This graph shows the effect of your home on the environment in terms of carbon dioxide (CO₂) emissions. The higher the rating, the less impact it has on the environment.
