Home Report

55 Pitairlie Road
Newbigging
Dundee
DD5 3RH

single survey

Property address	55 Pitairlie Road Newbigging Dundee DD5 3RH
Customer	Mr A Cruickshank
Prepared by	Graham + Sibbald LLP

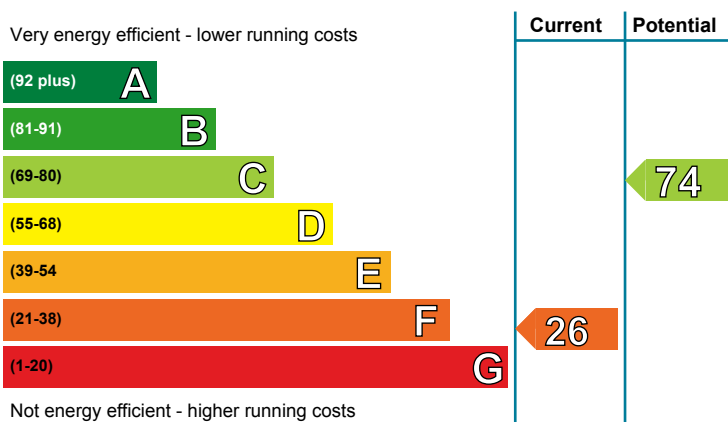
Energy Efficiency Rating

This graph shows the current efficiency of your home, taking into account both energy efficiency and fuel costs. The higher this rating, the lower your fuel bills are likely to be.

Your current rating is **band F (26)**. The average rating for EPCs in Scotland is **band D (61)**.

The potential rating shows the effect of undertaking all of the improvement measures listed within your recommendations report.
