23 Braemar Gardens,
Broughty Ferry,
Dundee,
Angus,
DD5 3TE

Home Report

Single Survey

Property Address	23 Braemar Gardens, Broughty Ferry, Dundee, Angus, DD5 3TE
Reference	DD202512-46436
Customer Name	Aimee Boath
Date of Inspection	19th December 2025
Surveyor's name, qualifications and office	Mark Smith BSc MRICS DM Hall LLP Chartered Surveyors Shed 26, Unit 34, City Quay Camperdown Street Dundee DD1 3JA Tel: 01382 873100 email: dundeeresidential@dmhall.co.uk
Prepared By	DM Hall LLP

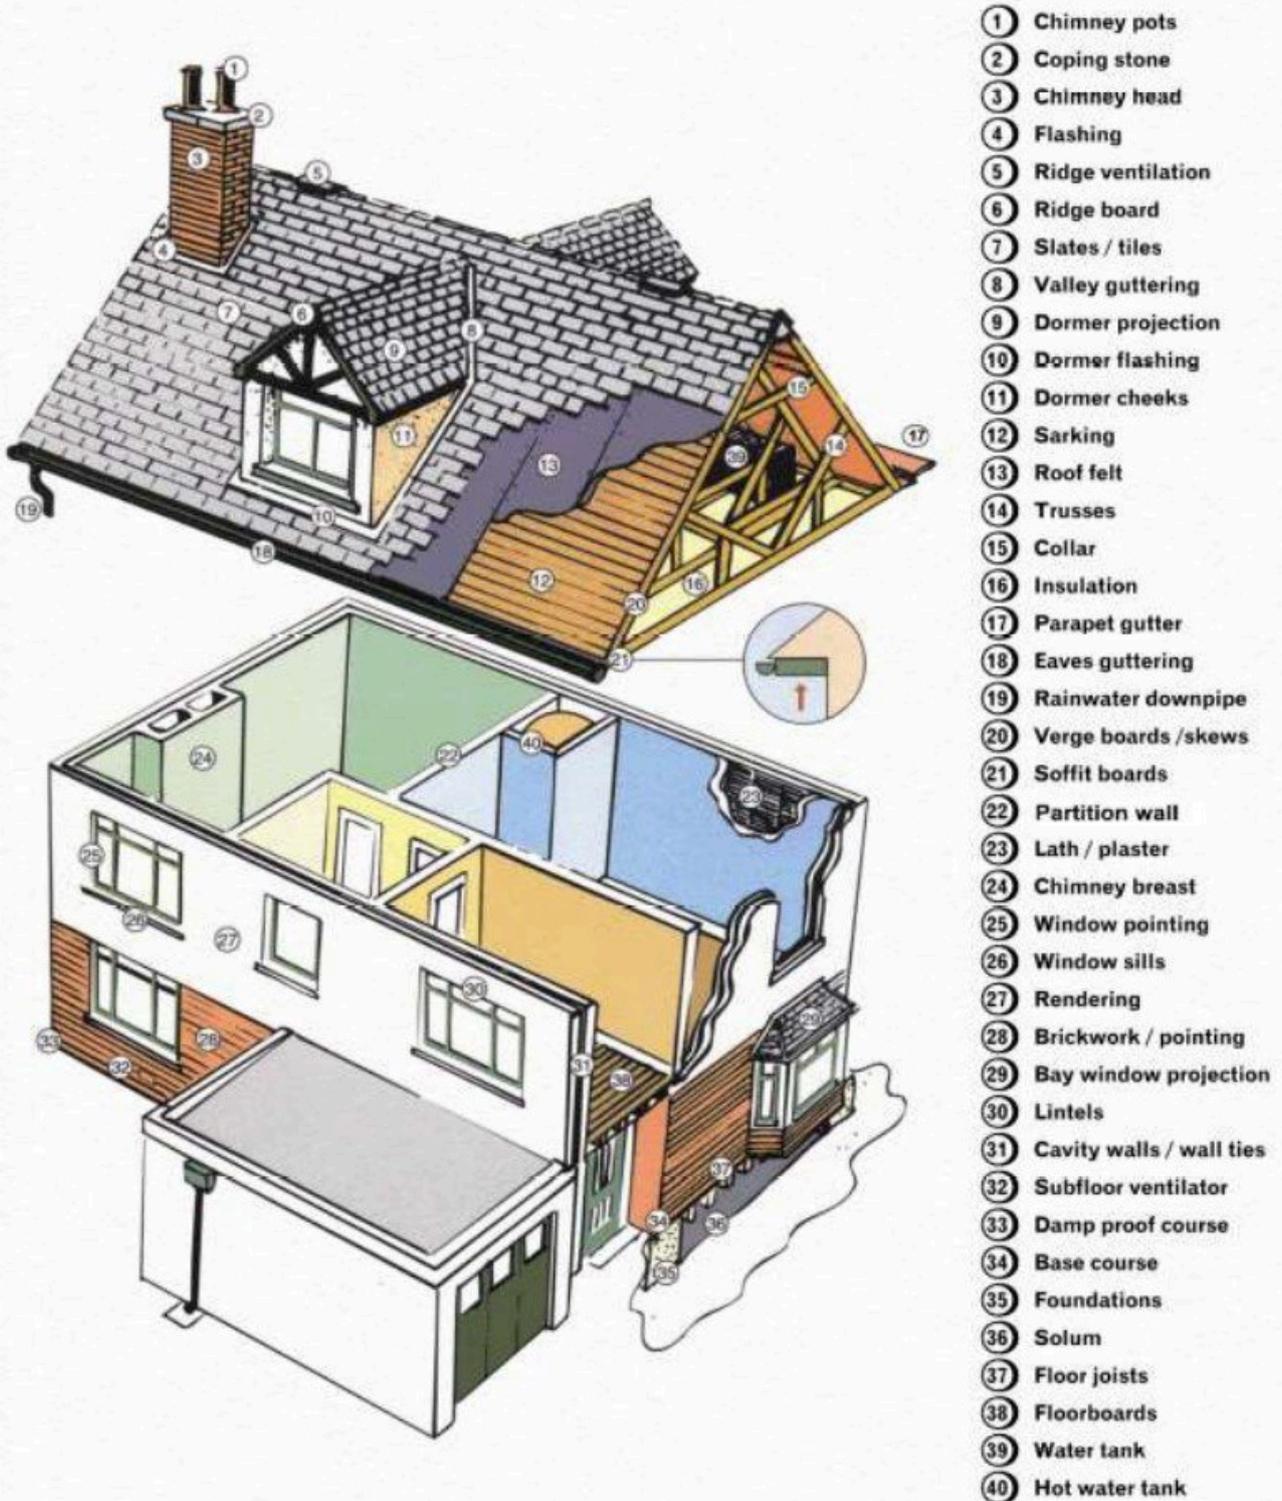
Sectional Diagram showing elements of a typical house

Reference may be made in this report to some or all of the above component parts of the property. This diagram may assist you in locating and understanding these items.

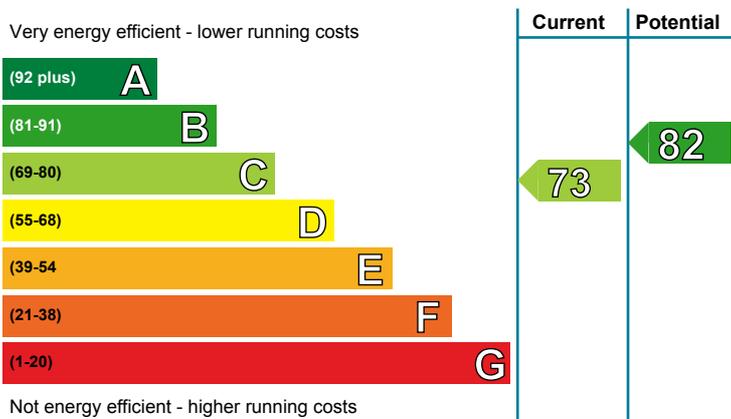
Energy Efficiency Rating

This graph shows the current efficiency of your home, taking into account both energy efficiency and fuel costs. The higher this rating, the lower your fuel bills are likely to be.

Your current rating is **band C (73)**. The average rating for EPCs in Scotland is **band D (61)**.

The potential rating shows the effect of undertaking all of the improvement measures listed within your recommendations report.

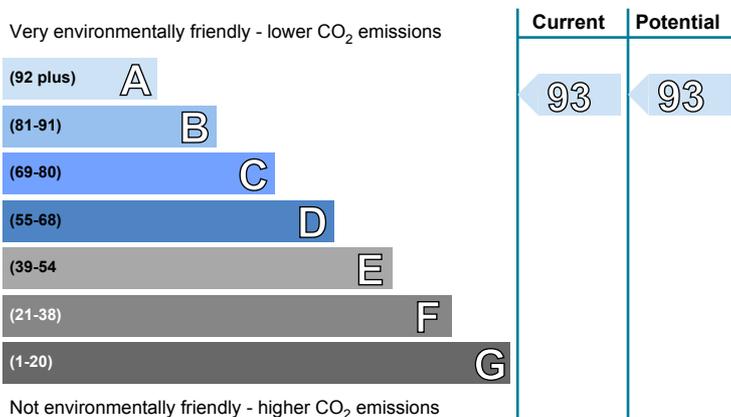
Environmental Impact (CO₂) Rating

This graph shows the effect of your home on the environment in terms of carbon dioxide (CO₂) emissions. The higher the rating, the less impact it has on the environment.
